Reproduction of fretting wear at the stem–cement interface in total hip replacement

L Brown, H Zhang*, L Blunt, and **S Barrans**
Centre for Precision Technologies, School of Computing and Engineering, University of Huddersfield, Huddersfield, UK

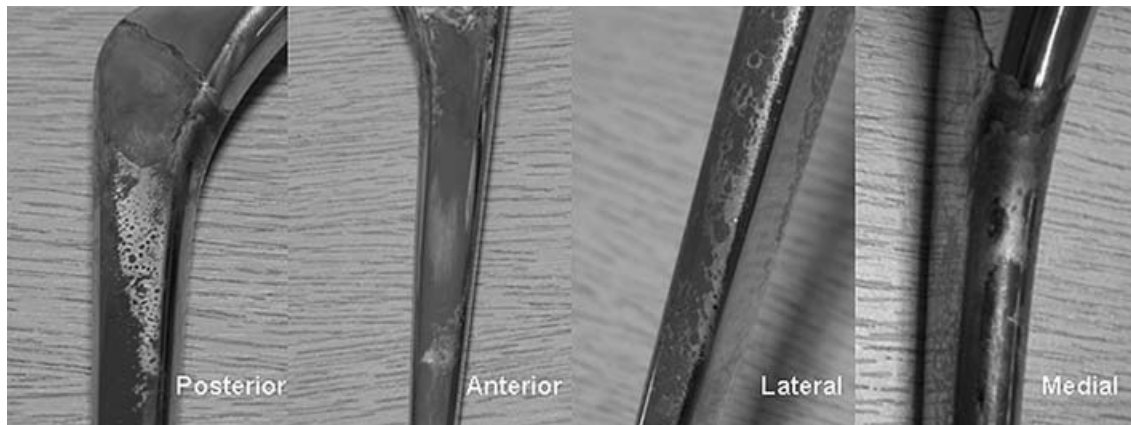
The Exeter V40™ femoral stem was found to be firmly fixated in the cement mantle after simulation. Following cautious extraction by a hammer and cleaning with alcohol, the stem showed evidence of fretting wear on all the surfaces (Fig. 3). The location of fretting wear was summarized as the coverage of the worn areas, evaluated by gross visual inspection (Table 2). These worn areas primarily concentrated on the anterolateral, posteromedial, and underneck zones of the stem surface, which compared well with the results of retrieval studies [15, 16]. The other

areas were relatively smooth and appeared undamaged. In addition, there was no evidence of formation of bone cement transfer films, which may be further removed as wear debris even if they were generated in the course of fretting wear simulation.

As can be clearly seen from Table 2, Gruen zones 6 and 7 on the stem posterior surface illustrated evidence of the most severe fretting wear. Therefore, a total of 20 measurements were carried out for each of these two Gruen zones, using the Talysurf CCI interferometer. Figure 4 showed one typical

| Stem surface	Fretting wear area (%)			
	Anterior	Posterior	Medial	Lateral
Zone 1	0	60		10
Zone 2	20	20		90
Zone 3	30	0		10
Zone 4	0	0	0	0
Zone 5	10	10	0	
Zone 6	30	80	10	
Zone 7	10	90	80

Fig. 3 Fretting wear generated on the stem surface after simulation, while no presence of bone cement transfer films is detected

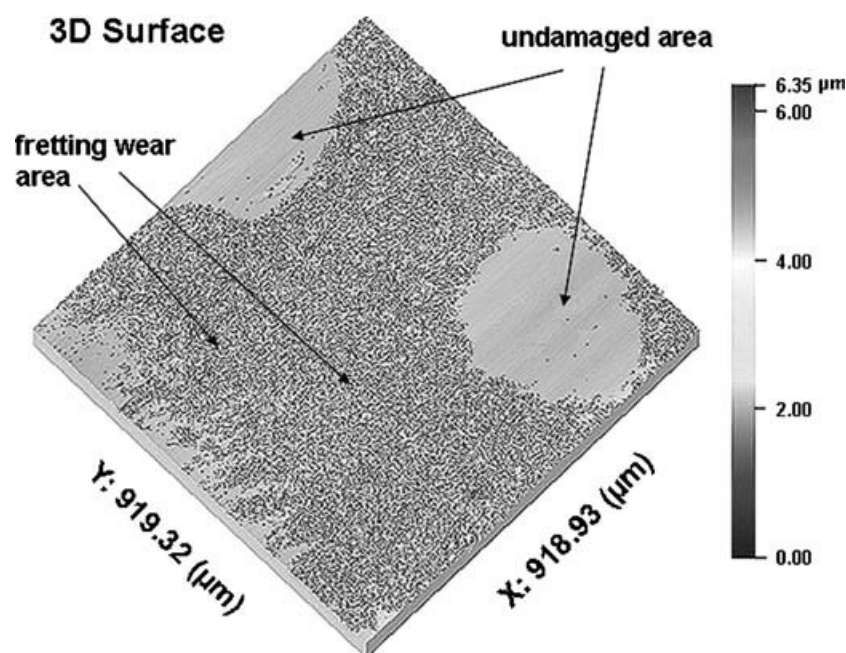
Fig. 4 Comparison between the fretting wear area and the undamaged area on the stem surface after simulation, the fretting zones are very rough while the undamaged area remains smooth

measurement performed in Gruen zone 6, which delineated the comparison of surface topography between the fretting wear area and the undamaged area. The values of the selected three-dimensional surface parameters were listed in Table 3, from which it can be seen that the stem surface had greatly changed. The significant increase in S_q, S_z, S_{dq}, S_{sc}, and S_{dr} all demonstrated that the stem was much rougher after simulation.

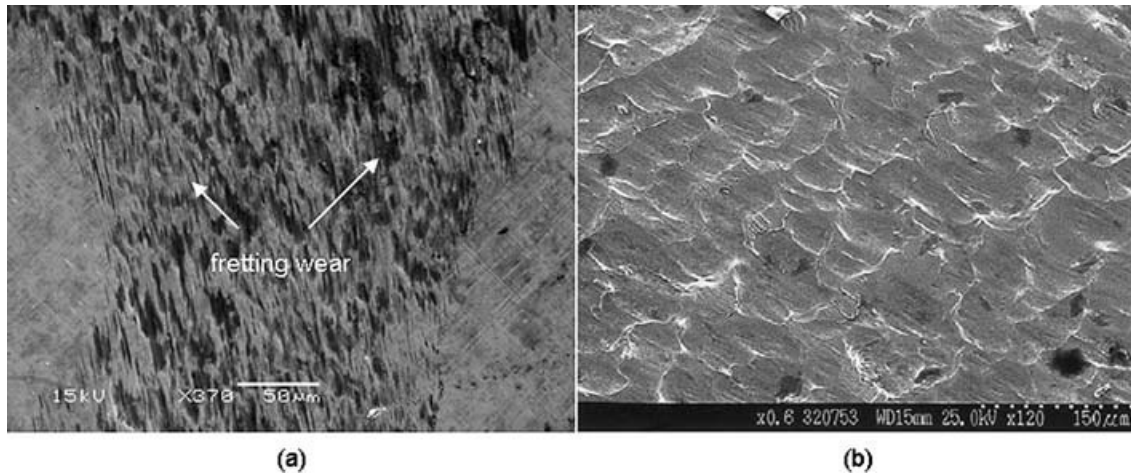
Figure 5 displayed the surface topography of the fretting zones on the simulated stem and on an explanted stem derived from a retrieval study [16], both of which were measured using SEM. The similar pitting and crater features again confirmed that fret-

ting wear was successfully reproduced in the present simulation.

Fig. 5 Scanning electron micrographs showing surface topography of the fretting zones on the stem surface: (a) the femoral stem from the present wear simulation; (b) an explanted femoral stem from retrieval studies

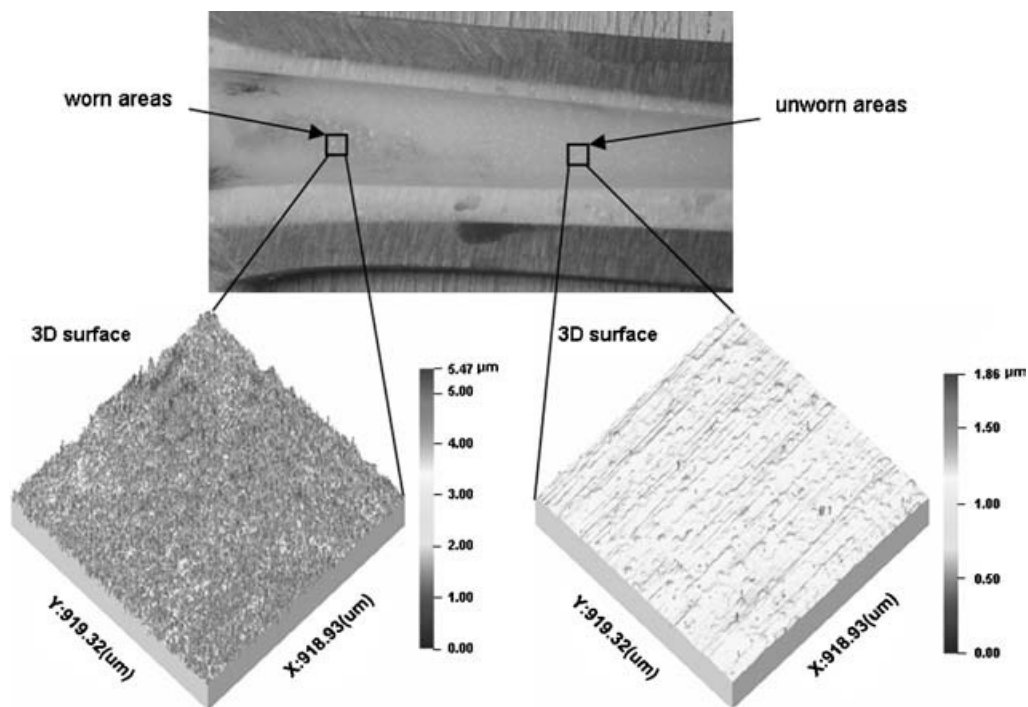
It was demonstrated from gross visual inspection of the cement surface that there were many micropores present in those areas in contact with the fretting zones on the stem surface, and these areas seemed much rougher than the other areas on the cement surface (Fig. 6). Hence, a total of 20 measurements were performed on the 'worn' and 'unworn' areas, using the Talysurf CCI interferometer. The mean S_q values were 0.21 μm and 0.04 μm respectively, which

Fig. 6 Comparison between the 'worn' and 'unworn' areas on the cement surface (3D, three-dimensional). The worn areas are in contact with the fretting zones on the stem surface

indicated that the 'worn' areas were severely damaged during the fretting process.

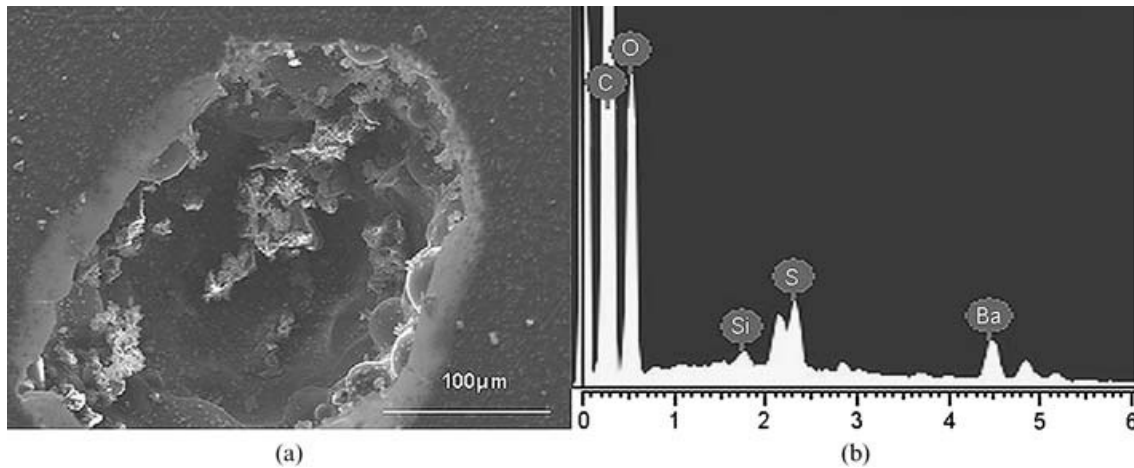
The investigation of the cement surface using SEM showed that there was an amount of fretting debris located in the micropores (Fig. 7). From the corresponding EDXA it was noted that an iron-rich plaque was not detected. This suggested that the debris was cement particles rather than metal particles. This debris was potentially worn off from the cement surface and then retained in the micropores.

Fig. 7 (a) Scanning electron micrograph showing wear debris located in the micropores in the cement surface; (b) the corresponding EDXA indicates that this debris is cement particles

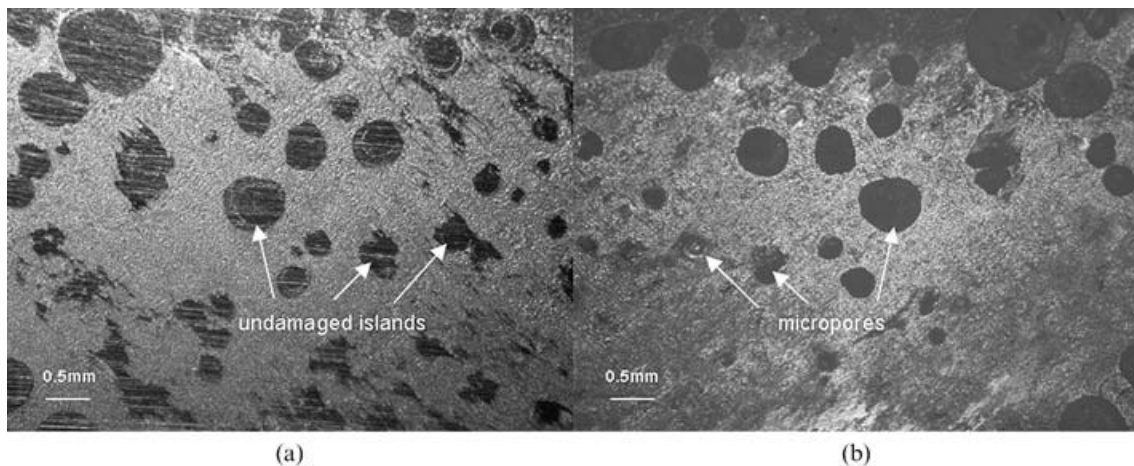
To gain a better insight into the initiation and propagation of fretting wear, the Exeter V40™ femoral stem and Simplex P bone cement were further investigated utilizing the Leica stereomicroscope. It was demonstrated on the stem surface that some 'undamaged islands' were surrounded by worn areas, which was in agreement with the result of another

study [17]. Interestingly, these undamaged 'islands' were found to correspond well to the micropores in the cement surface (Fig. 8). This indicated that these micropores may contribute to initiation and propagation of fretting wear on the stem surface. It is considered that the differential stress distribution across the differing thicknesses adjacent to the edge of the micropores would facilitate interfacial micromotion of the cement relative to the stem under physiological loading. This is essential to the generation of fretting wear on the stem surface.

Fig. 8 Optical micrographs of (a) the worn areas on the stem surface and (b) the corresponding zones on the cement surface. The black irregular circles are the 'undamaged islands', which matched the micropores in the cement surface well
